APPENDIX 1c – Interim Estates Strategy

Updating the Trust's Estates Strategy

**REPORT FOR SHREWSBURY AND
TELFORD HOSPITAL NHS TRUST—
7 FACET SURVEYS SUMMARY
REPORT
PRINCESS ROYAL HOSPITAL**

SIX FACET REVIEW

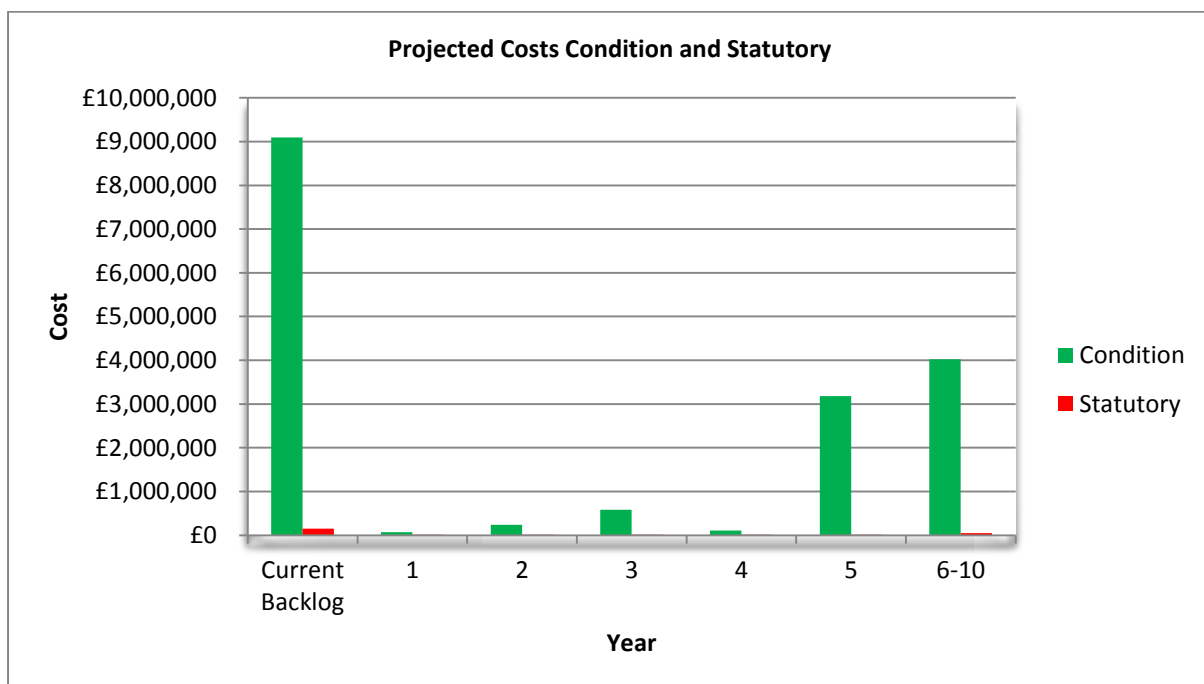
Chart 1 - Condition and Statutory Costs (Years 0 - 10)

The total projected cost for the rectification of all items identified under Condition is £17,310,032. The total cost for Statutory Compliance is £253,690. An indication of the projected costs per year is shown in Chart 1 below.

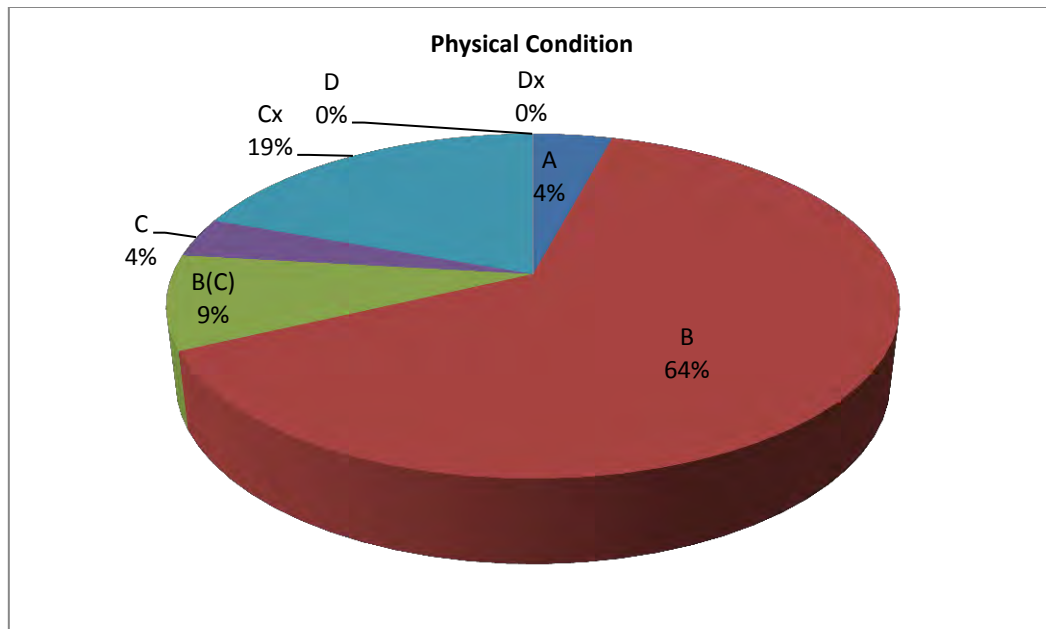
Chart 2

A breakdown of the various ratings for both Condition and Statutory are shown in Charts 2 and 3 below.

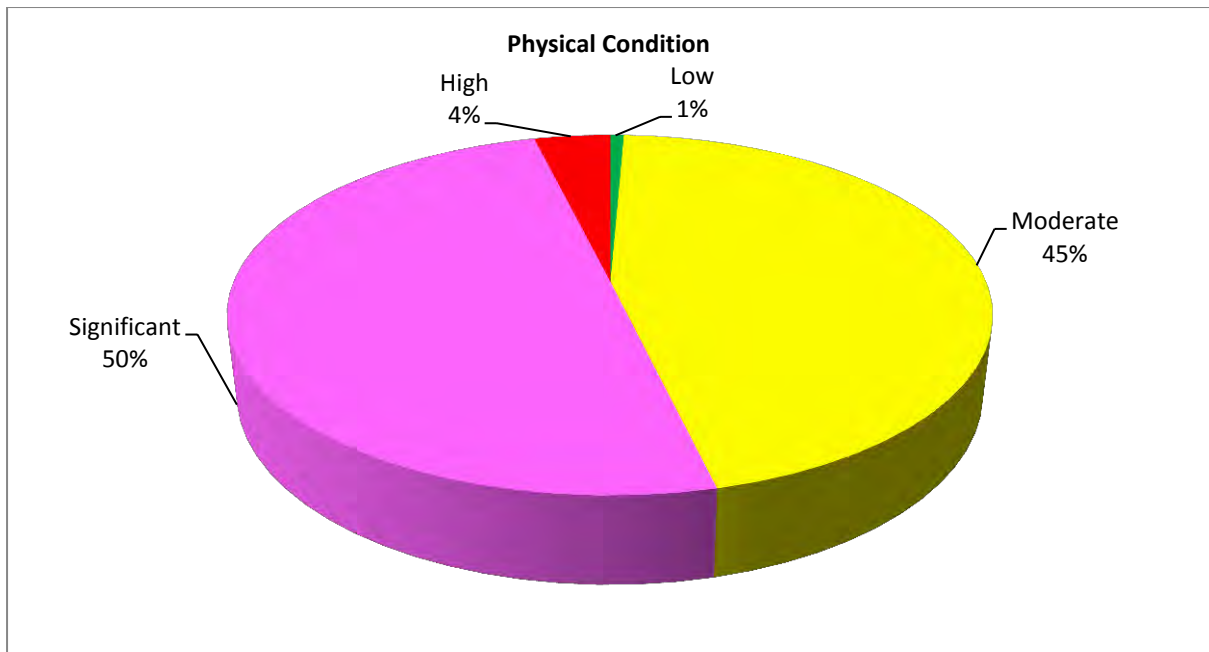
Chart 4

A breakdown of the backlog costs, by risk for both Condition and Statutory are shown in Charts 4 and 5 below.

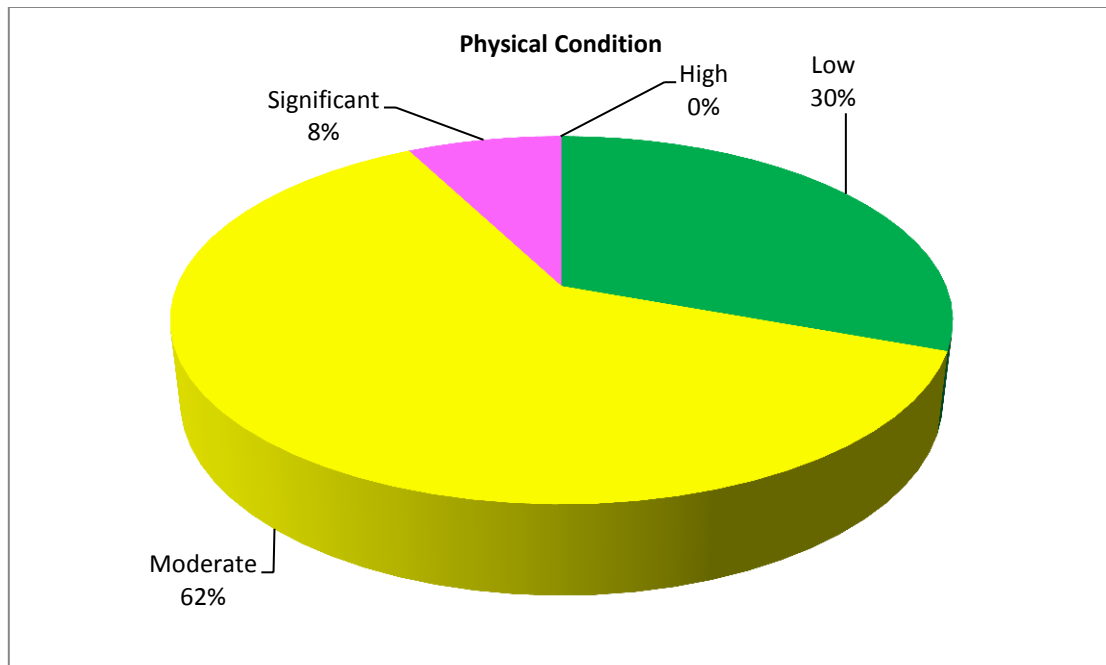
A breakdown of the impending backlog, by risk for Condition is shown in Chart 6 below.

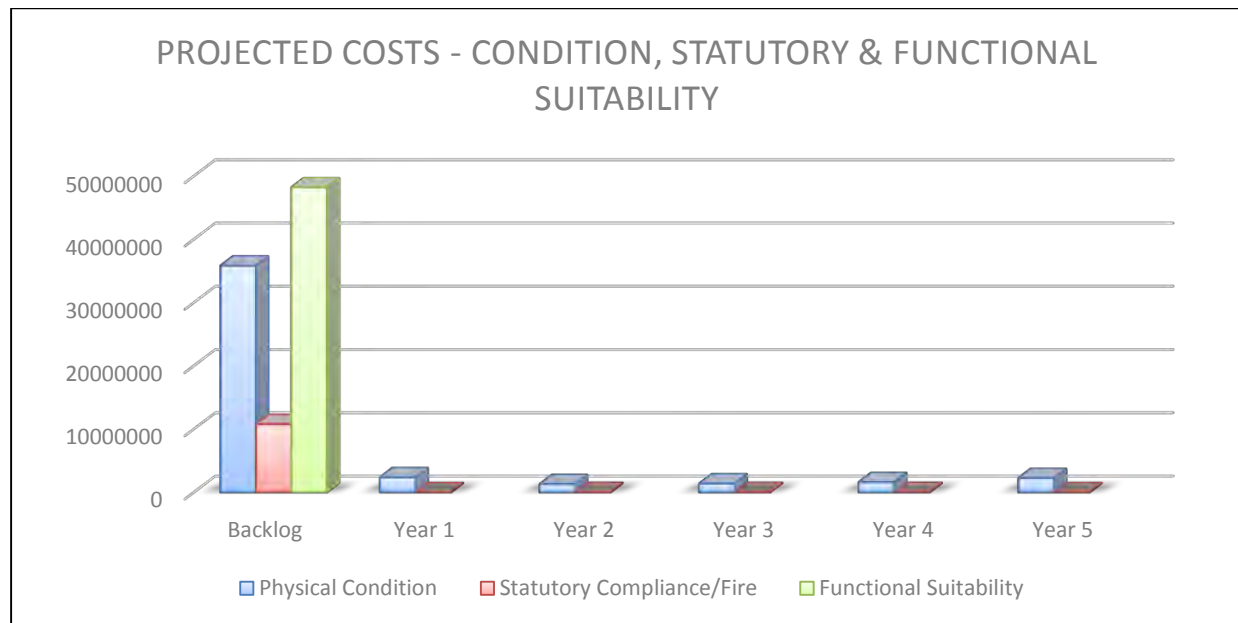
An indication of the projected costs per year is shown in the Chart below.

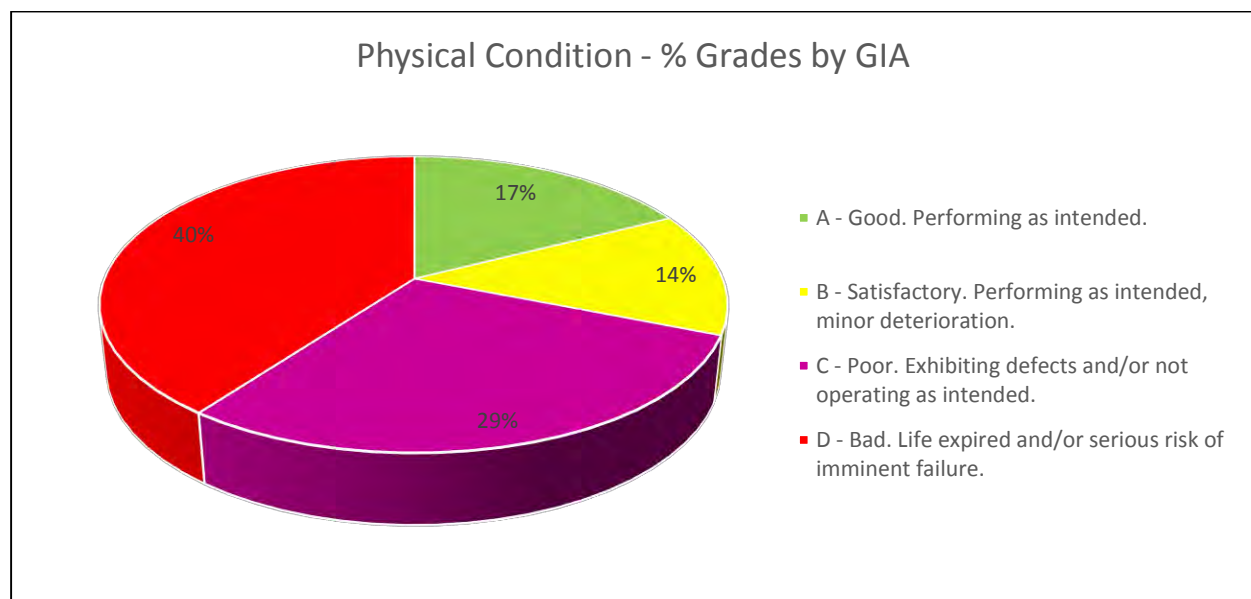
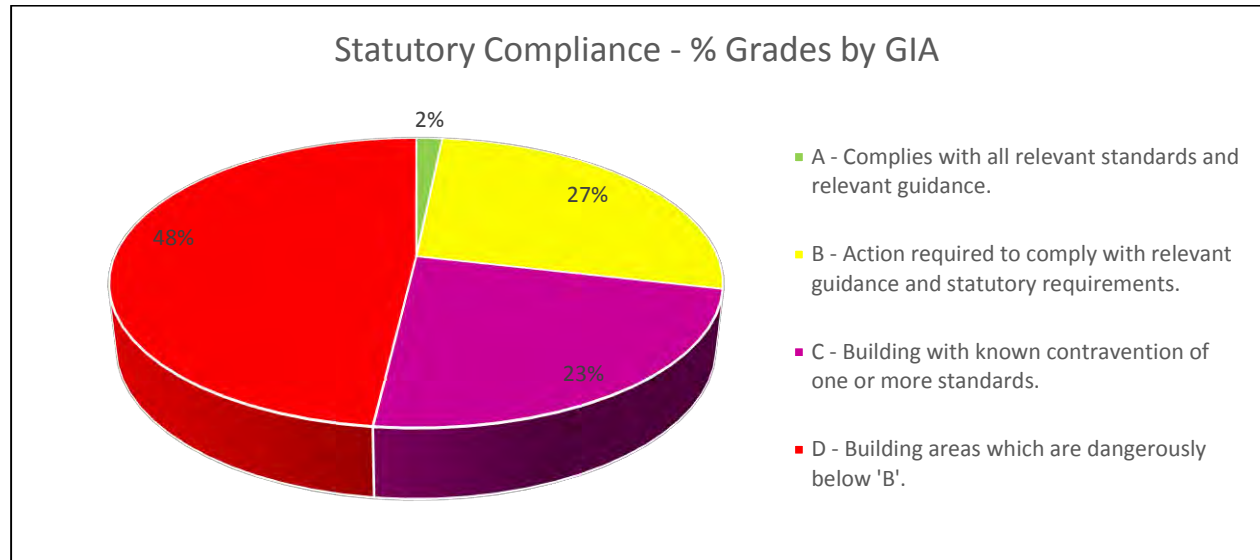
A breakdown of the block gradings for each facet (percentage based on GIA of building)

The pie charts above shows the grades of the blocks surveyed. *This is based on the surveyor's subjective view of the overall condition of the block.*

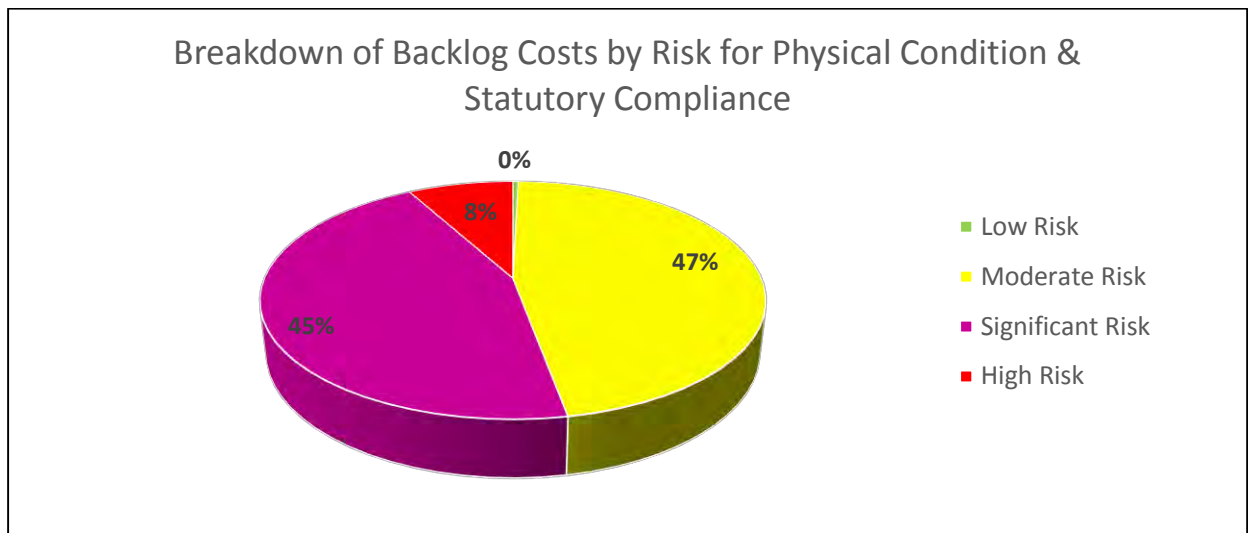
Backlog Summary	Physical Condition	Statutory Compliance
Low Risk	£185,250	£0
Moderate Risk	£11,752,650	£10,000,000
Significant Risk	£20,893,500	£0
High Risk	£2,990,300	£752,100
Total Backlog	£35,821,700	£10,752,100

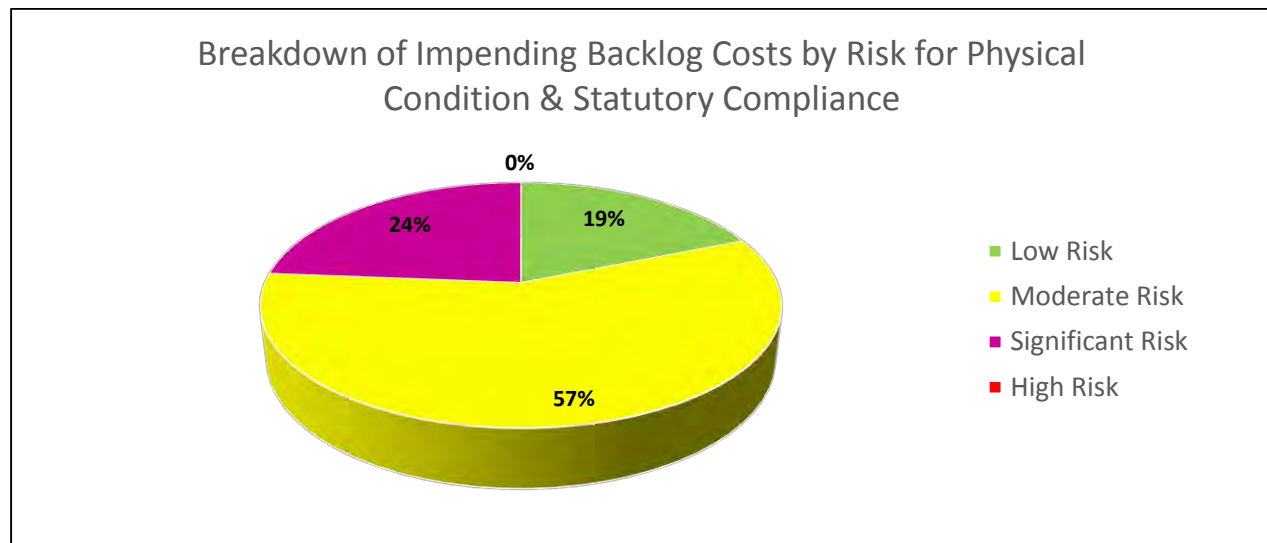
Impending Backlog Summary	Physical Condition	Statutory Compliance
Low Risk	£1,675,250	£0
Moderate Risk	£5,051,352	£49,150
Significant Risk	£2,111,250	£0
High Risk	£0	£0
Total Impending Backlog	£8,837,852	£49,150

Note that nominal cost statutory items refer to local lifecycle failures of fire equipment only

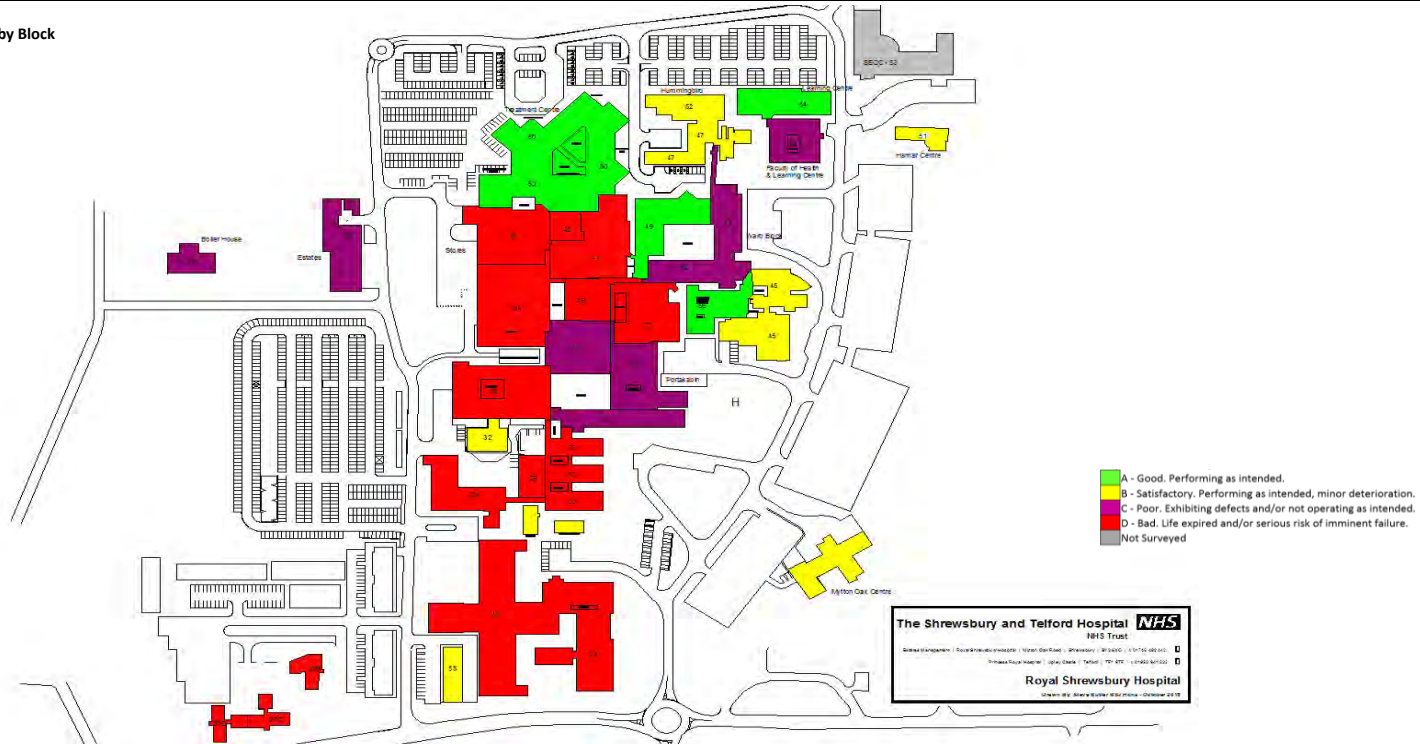
Site Plan showing Overall Grades by Block

Royal Shrewsbury Hospital is a medium sized acute hospital located to a sloping site on the Western edge of Shrewsbury town centre. Buildings to the site are predominately of concrete frame construction and built circa 1970 with numerous additions built circa 2005 which include the Treatment Centre and the Ward Block Extension.

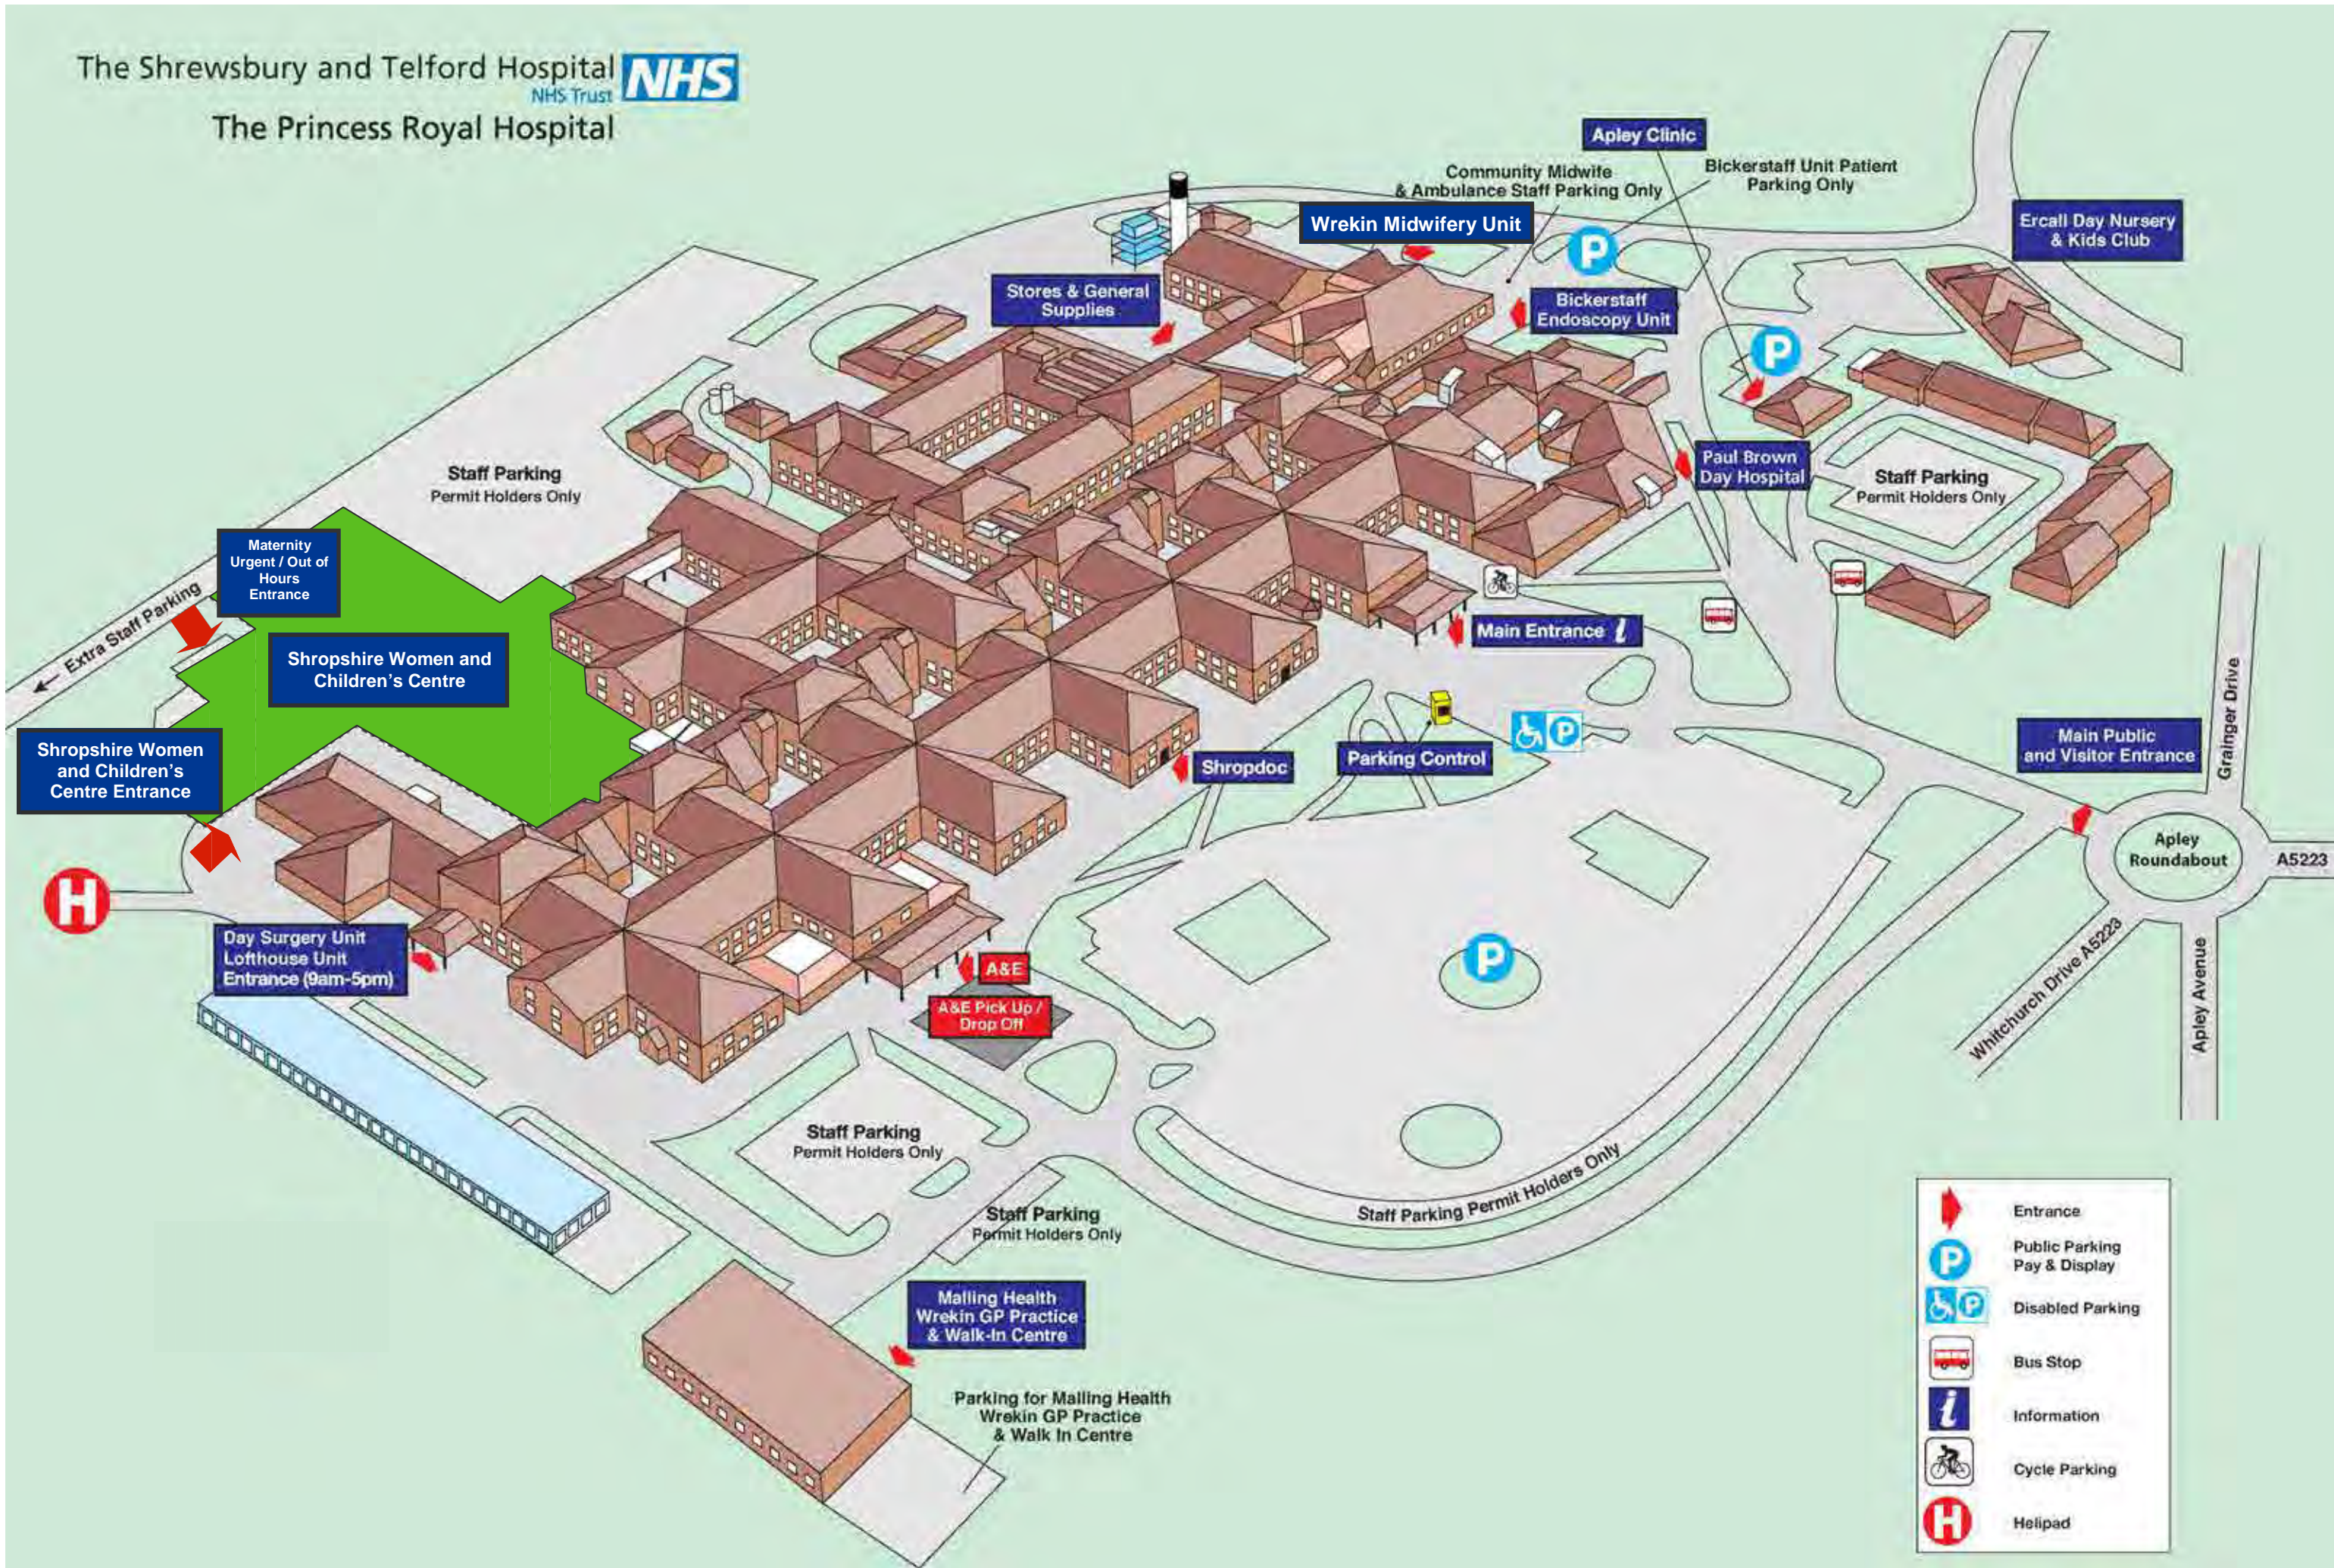
APPENDIX 1e- PRH EXISTING SITE PLAN

-   Entrance
-   Public Parking Pay & Display
-   Disabled Parking
-   Bus Stop
-   Information
-   Cycle Parking
-   Helipad
